# Beam Gentries Maintenance & Repair Manual

Issue: 6

Date: December 20

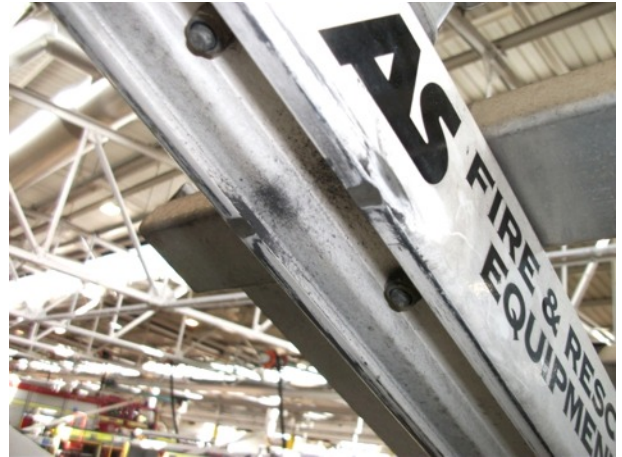
### Examples of wear to the beam and roof rollers:

This is caused by lateral movement of the beam on the roller. The beam can wear over a long period of time leaving aluminium deposits, which with water and other grime turns into a cutting paste speeding up the degradation. Cleaning the beam regularly will help to reduce this wear but won't eradicate the problem.

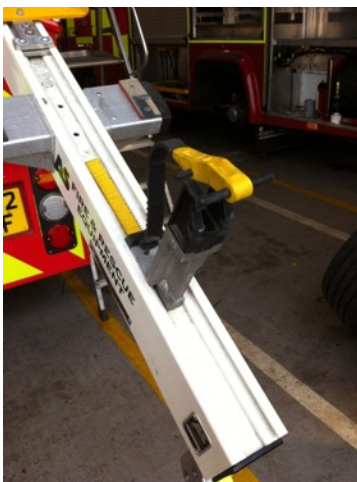
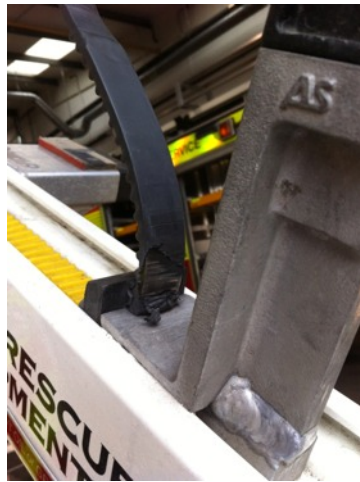
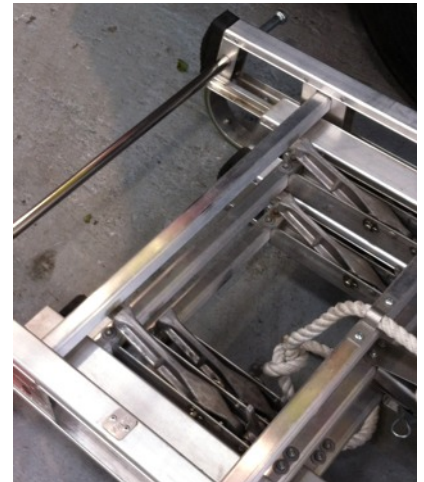
### Examples of wear on the gantry straps and the ladder:

This may indicate that there is too much play in the ladder on the gantry and the stop block on the headslide has worn or possibly broken. As a result the bottom rung on the ladder has worn. It is easy and cheaper to replace the strap than it is to replace the ladder rung.
